OSCARVILLE HEALTH CLINIC

Alaska Rural Primary Care Facility Code and Condition Survey

February 18, 2002

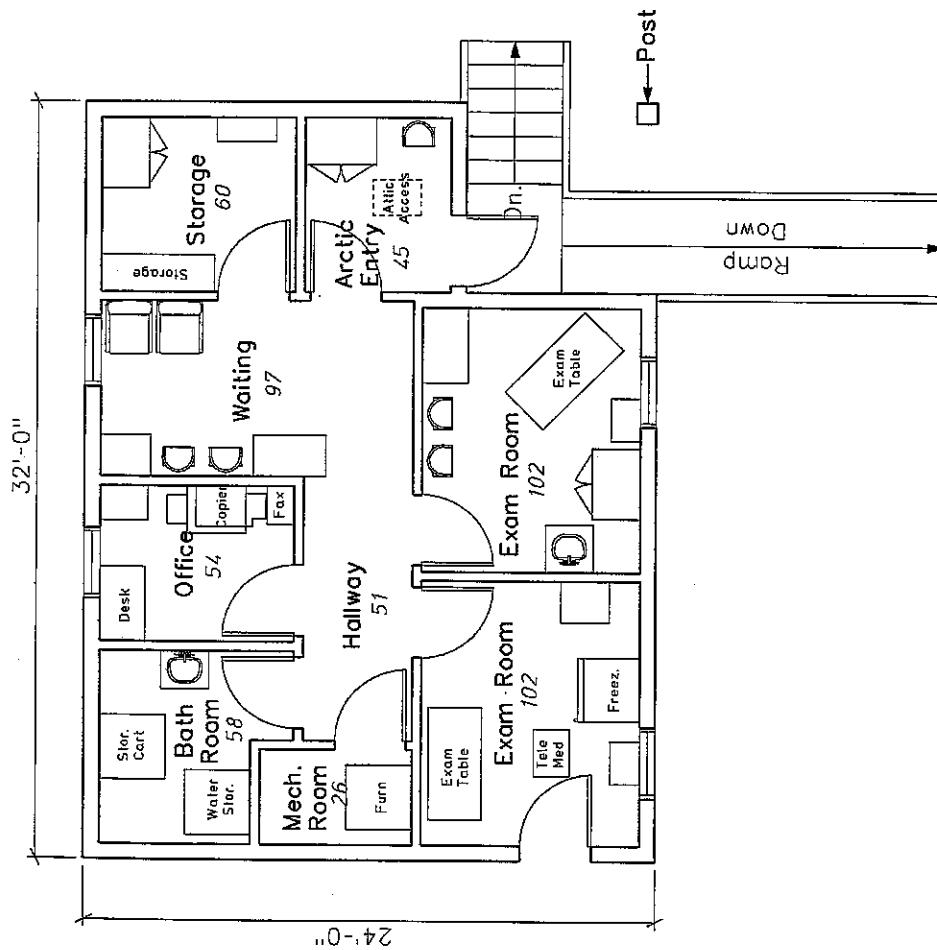
Existing Oscarville Clinic Floor Plan

- Overall space deficiencies: The size of the facility is about 796 sf short of the ARPCF space requirements.
- Specific room deficiencies: There is minimal vestibule, small waiting space, minimal office and storage space, small exam rooms, no bath facility, and no TDY space in a very inaccessible community. This in combination with other small spaces leaves the clinic very program deficient.
- Other size issues: Mechanical room is very small, and there are no unheated or exterior storage areas, and circulation is through the exam room to get to second exit.

The floor is 2x10 joist over a 6x10 beams with treated post and pad foundation with 3 x 12 treated pad for foundation system. There is some settlement and heaving which has caused doors to stick and floor to be uneven. There is approximately 1 inches of differential in the floor elevations. There is batt insulation of the 2x10 joist space with 3/8" plywood soffit.

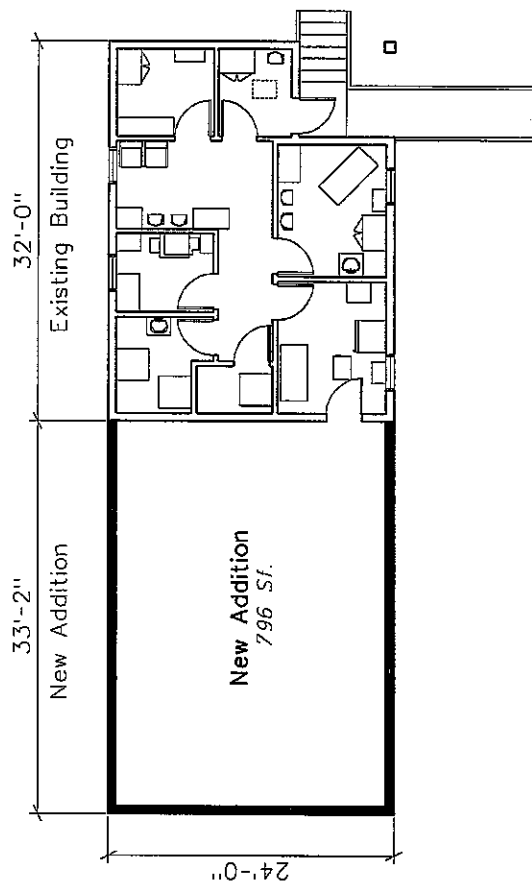
New Addition Oscarville Clinic Floor Plan

796 Sf. + 704 Sf. = 1,500 Sf.

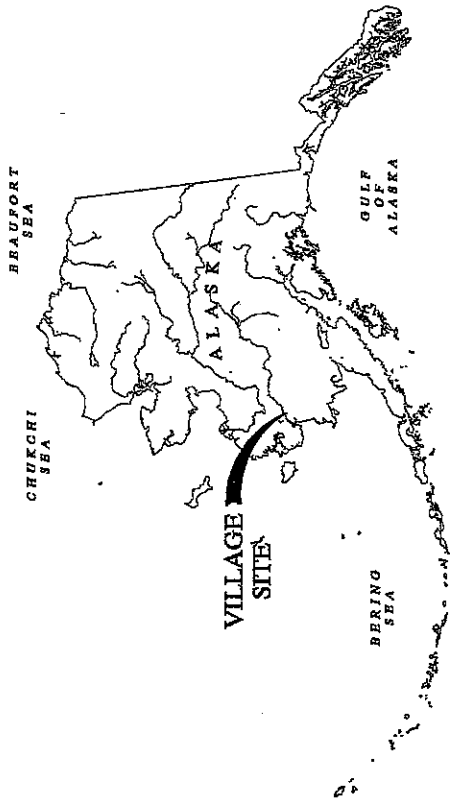
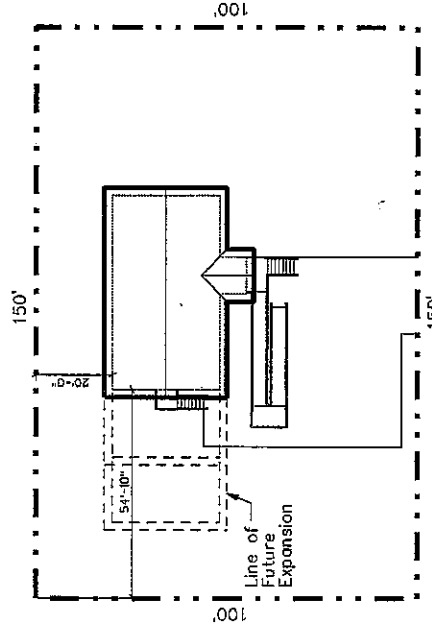
New Site Plan
Scale: 1" = 50'

The community has proposed that a new larger 1500 SF Denali Commission Small Clinic can be constructed on a new site, of which there are a couple of choices. We have included preliminary site plans which show one of the potential sites.

All of the sites have existing city utilities available to them and can be served easily. The Tribal Administrator of Oscarville, Ignati Jacob, is in process of final determination of the final site selection and should have this complete in the next couple months.

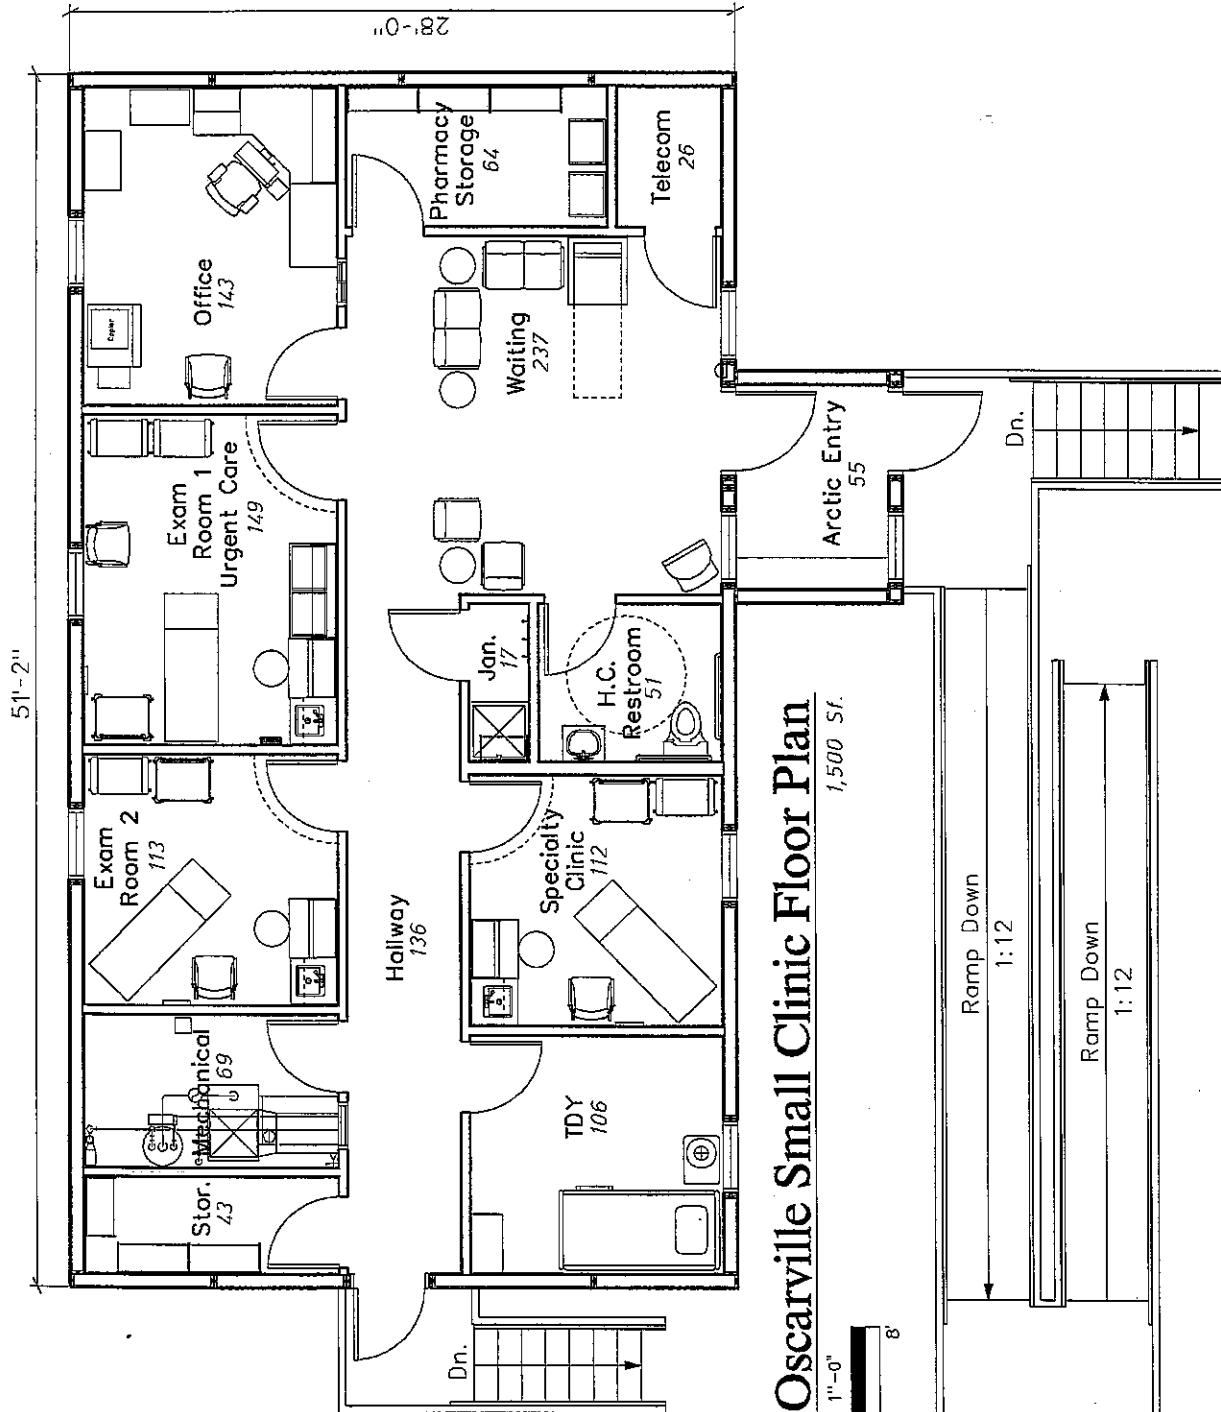
New Oscarville Small Clinic Floor Plan

1,500 Sf.

After careful review it is the recommendation of the consultant team that a new Denali Commission 1500 SF Small Clinic be considered for Oscarville. The addition of approximately 796 sf of clinic space required by the current ARPCF Program Space Guidelines and the major renovation and upgrading of the existing clinic space will cost 1.92 times the cost of a new clinic. This results in the recommendation of a new clinic for this village.
